MEMORANDUM
VIRGINIA DEPARTMENT OF ENVIRONMENTAL QUALITY
SOUTH CENTRAL REGIONAL OFFICE
WATER DIVISION

SUBJECT: VPDES PERMIT # VA0006513, REISSUANCE SITE INSPECTION, TOWN OF GRETN
DRINKING WATER TREATMENT PLANT (WTP)

DATE: September 10, 2009

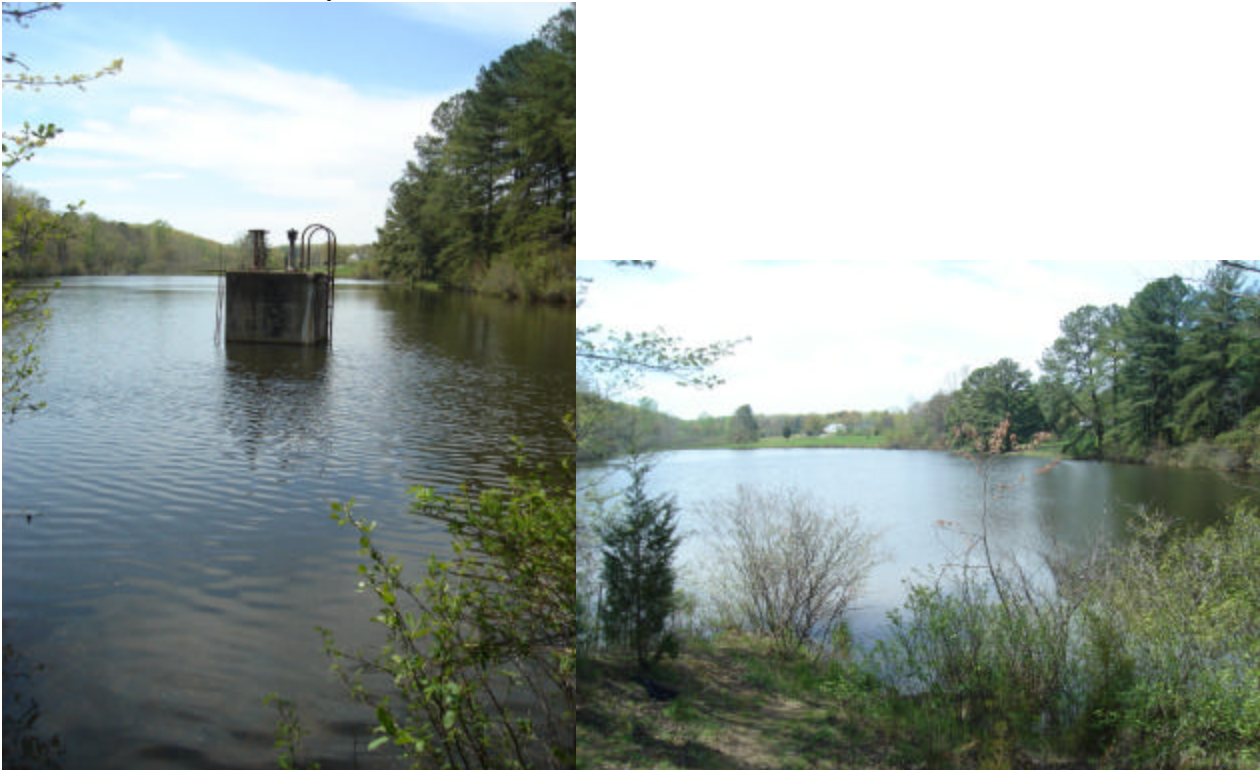
The town currently draws water out of the town reservoir, below w. This reservoir overflows the

spillway and forms Georges Creek, a tributary of the Roanoke river, which is also the receiving stream for the WTP discharge.

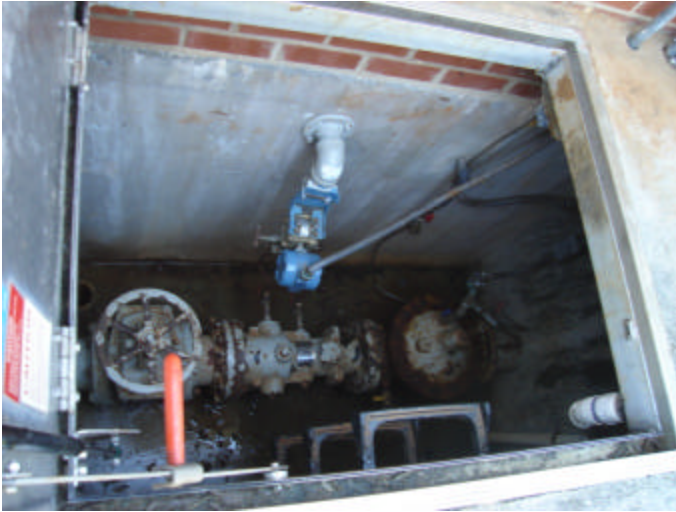
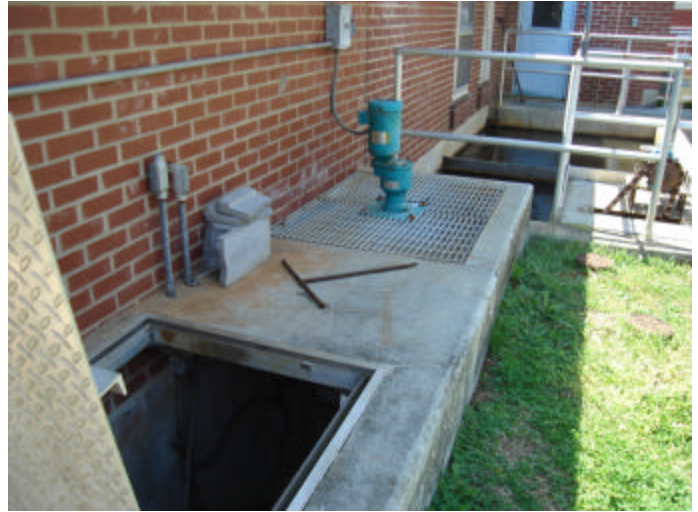
Raw water is piped to the initial chemical mixing tank below.

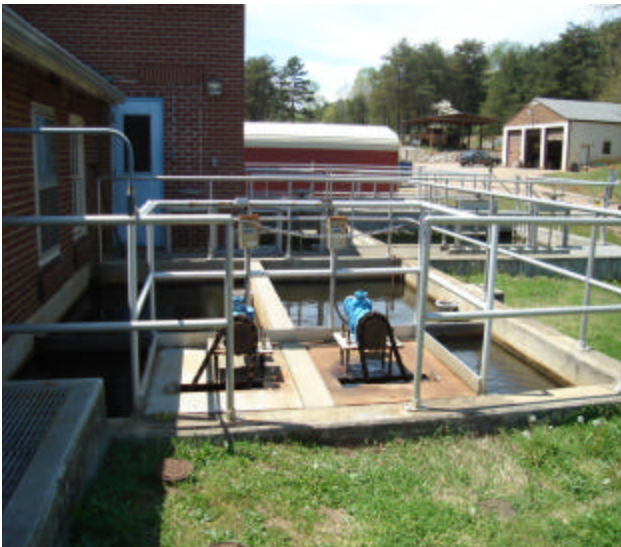
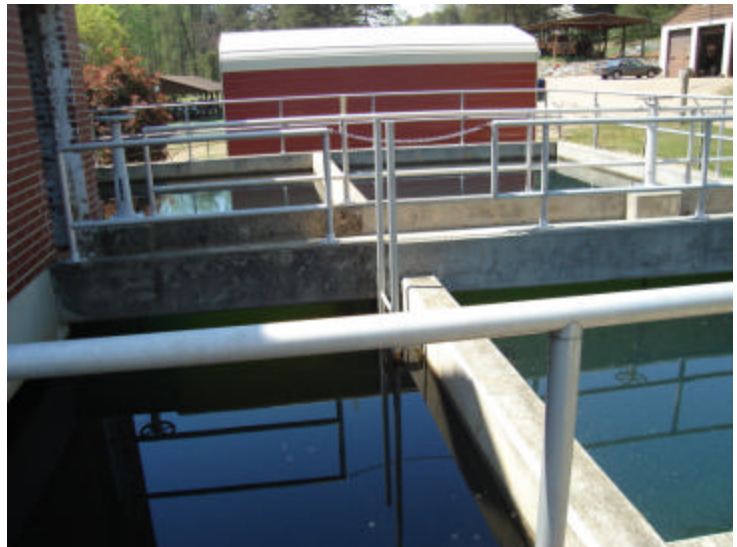
Chemicals are added that help generate floc to treat the water, and are mixed prior to entering the flocculation basins. Next the water flows to the plant flocculation basins, and then to the settling basins below. The basins are operated in two parallel trains.

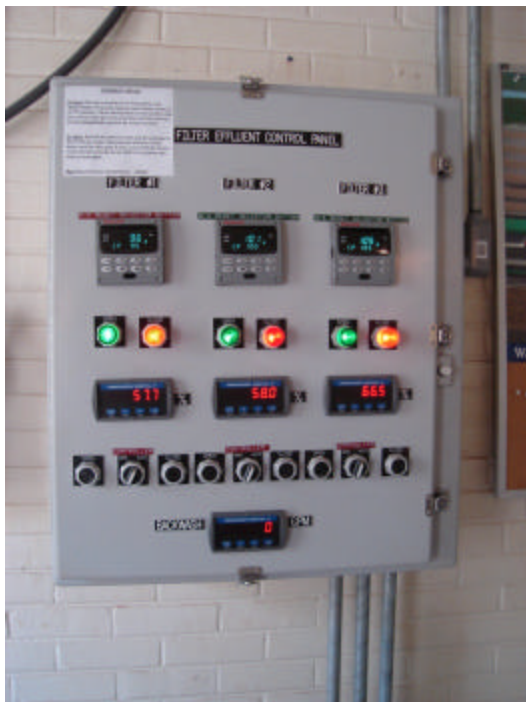
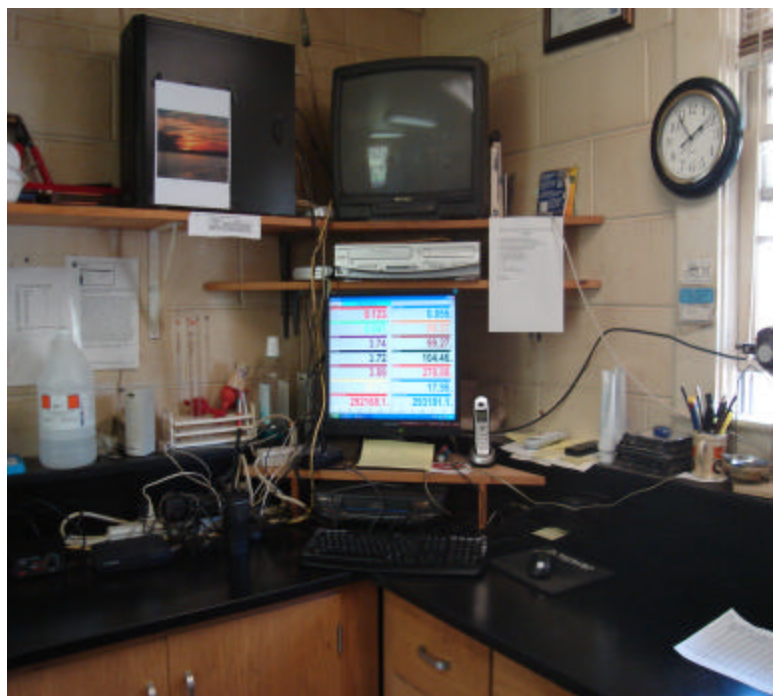
Since the last VPDES reissuance, the plant has been significantly updated, and now has a computerized management system, which provides real time data to the operator.

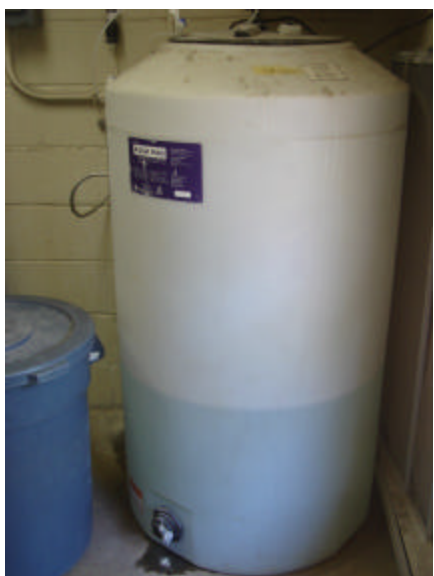
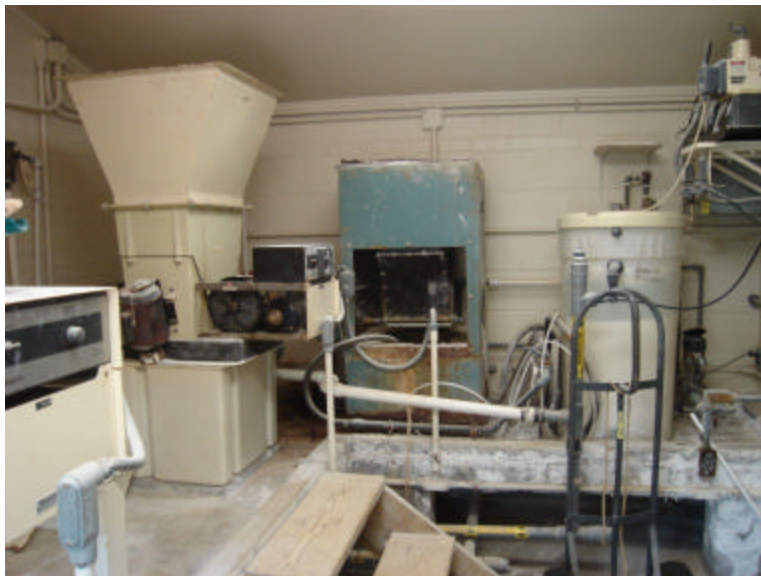
Chemicals are housed in two rooms in the plant as below
